# BEAR LAKE MARINA EXPANSION UTAH STATE PARKS

## Programming Report

DFCM Project No.: 15120510

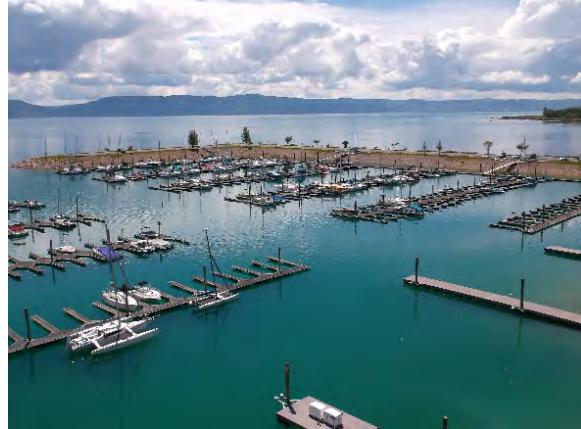
*Figure 2-1: Existing Bear Lake Marina Looking South over Future Marina Site*

The Marina will house 343 long-term boat slips with utility service, internet and cable television service. There will also be 17 transient boat rentals available for overnight storage or weekend stays. There will be a crane pad (130' x 110') to lift large boats to and from the water. The pad will be made of a Mechanically Stabilized Earth (MSE) or Hilfilter wall, quite similar to the existing pad.

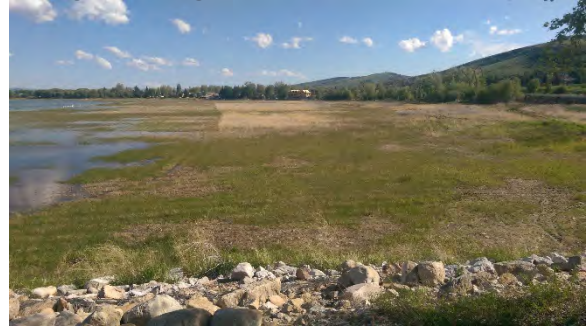
Figure 2-2: Planned Site of Bear Lake Marina Expansion Looking South along the Shoreline

The project area will impact approximately 1,000 feet of the west shoreline of the lake adjacent to US-89 which is shown in Figure 2-2. The shoreline consists of a steep embankment from the edge of the highway down to the lake bed. The shoreline area includes several large trees including cottonwoods and willows. A detailed investigation of the shoreline was to determine wetlands in this area. The US Army Corp of Engineers (USACE) has jurisdiction over wetlands. Details of the investigation are found in Appendix B.

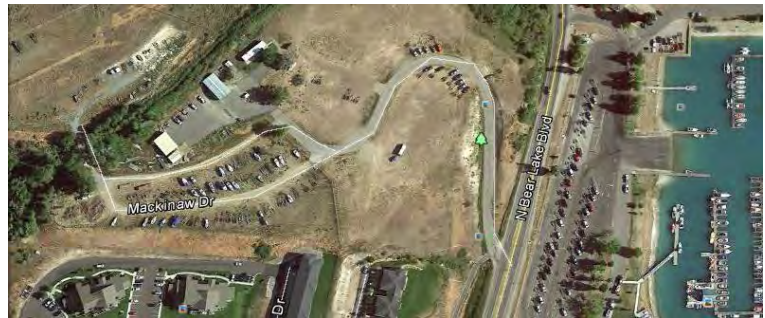
Figure 2-4: Overflow Parking

Overflow parking is located on the west side hill of US-89 as shown in Figure 2-4. This area is accessed by a paved steep roadway from US-89 that extends to the Division of Wildlife Resources Offices. The street intersection to the overflow parking area does not meet current State of Utah design standards and poses some safety concern. The overflow parking area surface is dirt and grass and does not have any formal layout for vehicles.

With the overflow parking across the highway, pedestrians crossing traffic to access the marina causes another significant safety issue.

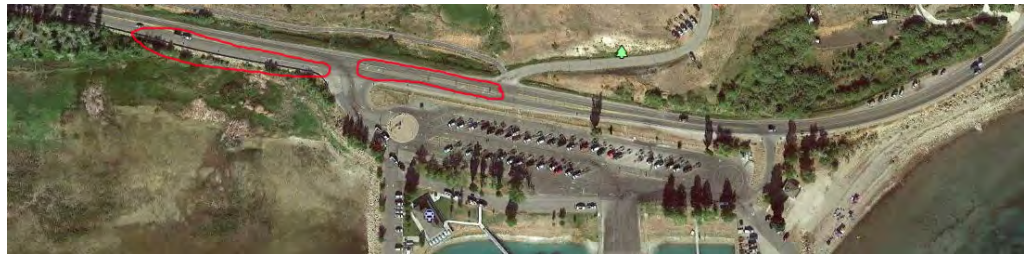
Figure 2-5: Aerial Image of Right and Left Turn Lanes on US-89

In Figure 2-5, US-89 is shown as directly west of the marina. It is a primary corridor for travelers from the Wasatch Front to Yellowstone

National Park. In 2008, the Annual Daily Traffic (AADT) was 1590. A right turn lane into the marina was constructed in 2000 to provide additional queuing into the marina and increased traffic safety. In 2013 the AADT was 2480 and at times traffic still backs up onto the through lanes impeding traffic on US-89 northbound, a short section of left turn lane exists between the overflow parking intersection and main entrance into the marina. Quick maneuvering is required to exit the marina and turn onto the overflow parking road or vice versa. This often leads to regular traffic accidents.

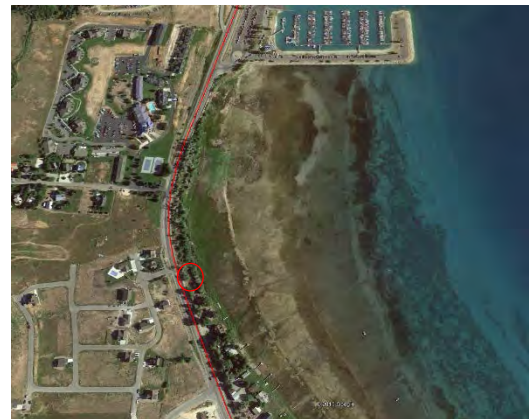
Figure 2-6: New Home Build to South of Marina Expansion.

A new residence is being constructed immediately south of the State Property on the east side of US-89. This is displayed in Figure 2-6.

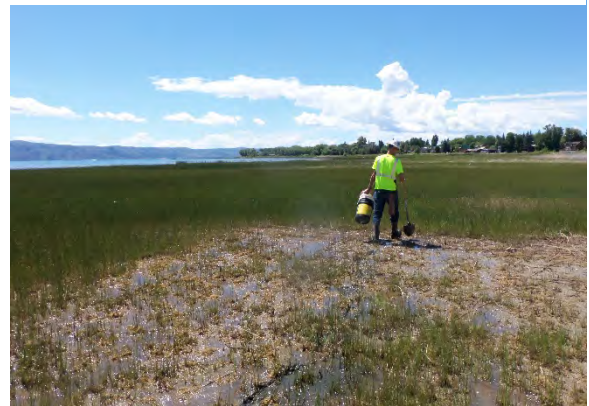
Figure 2-7: Geotech Survey on Future Site

The Geotechnical Report and Geologic Survey was completed by Terracon, Inc., Geotechnical Engineering Consultants, as part of the Geotechnical Investigation as shown in Figure 2-7. The Bear Lake Graben borders the east edge of the Marina dike. This is the location of a seismic fault. The geotechnical report has not identified this as an area of concern for the project. Otherwise, there are no geologic concerns that were identified that will significantly affect the schedule or cost of the project. The geotechnical findings can be found in the Geotechnical Report in Appendix A.

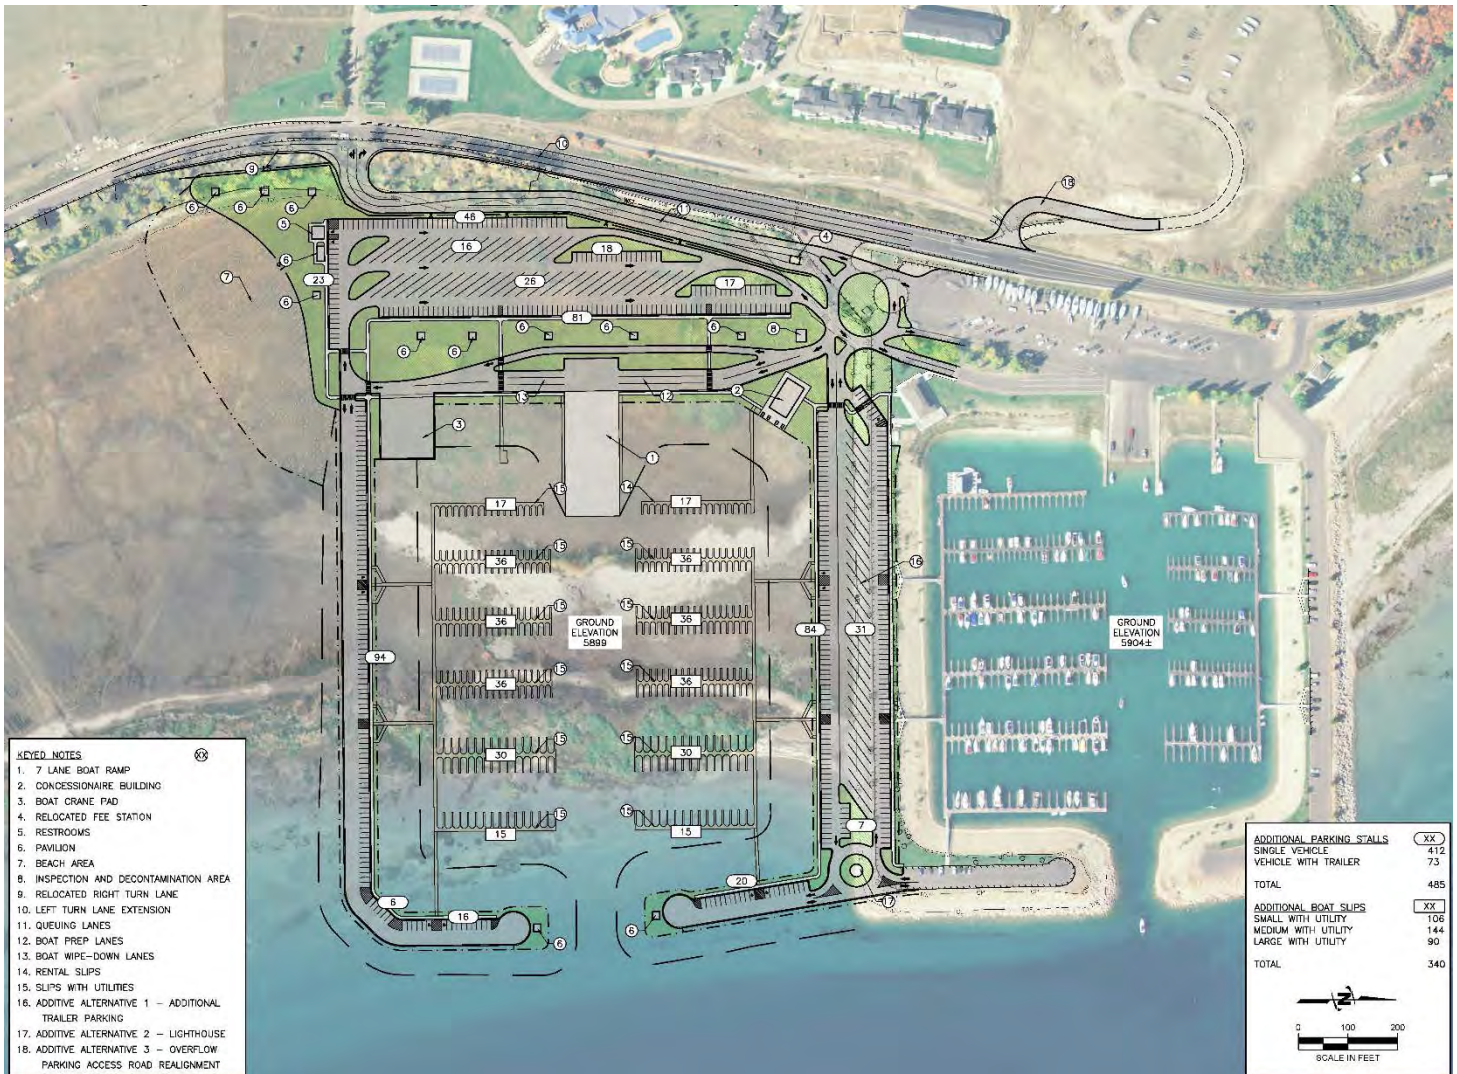
Figure 2-8: Aerial Map and Specifications of Planned Site

Figures 2-8 and 2-9 give conceptual renderings of the planned improvements. Site Drawings, Specifications and Studies for the project are found in the appendices.

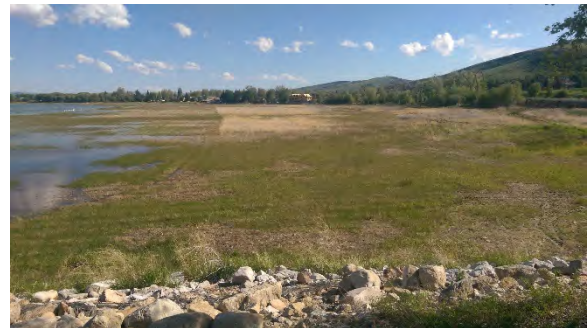
*Figure 2-10: South facing view of proposed Marina Expansion site*

The Marina expansion location is on the west side of Bear Lake near the mountains immediately south of the existing marina. The mountains run north and south, so the site will receive direct sunlight in the morning as the sun rises and be shaded in the early evening by the mountains. In the mid-summer, sunlight will be directly overhead while in the winter months, the sun is in the southern sky. The concessions building should consider these solar exposure conditions in design to take advantage of the potential benefits. The restroom and fee station buildings are small or have little options for window placement, resulting in little benefit from solar exposure.

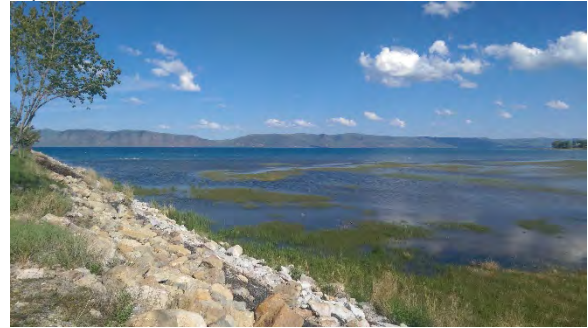
Figure 2-11: East facing view of proposed Marina Expansion site

The project site offers sweeping views to the east and mountain views to the west. East of the site is the lake. No building will occur between the marina and the lake, so views will be unobstructed from north to south in an easterly direction. The site planning should focus on the eastern views to achieve the greatest advantage. The western view contains the mountain range. While western vistas are potentially good they have been influenced by development of condominiums and cabins opposite of US-89.

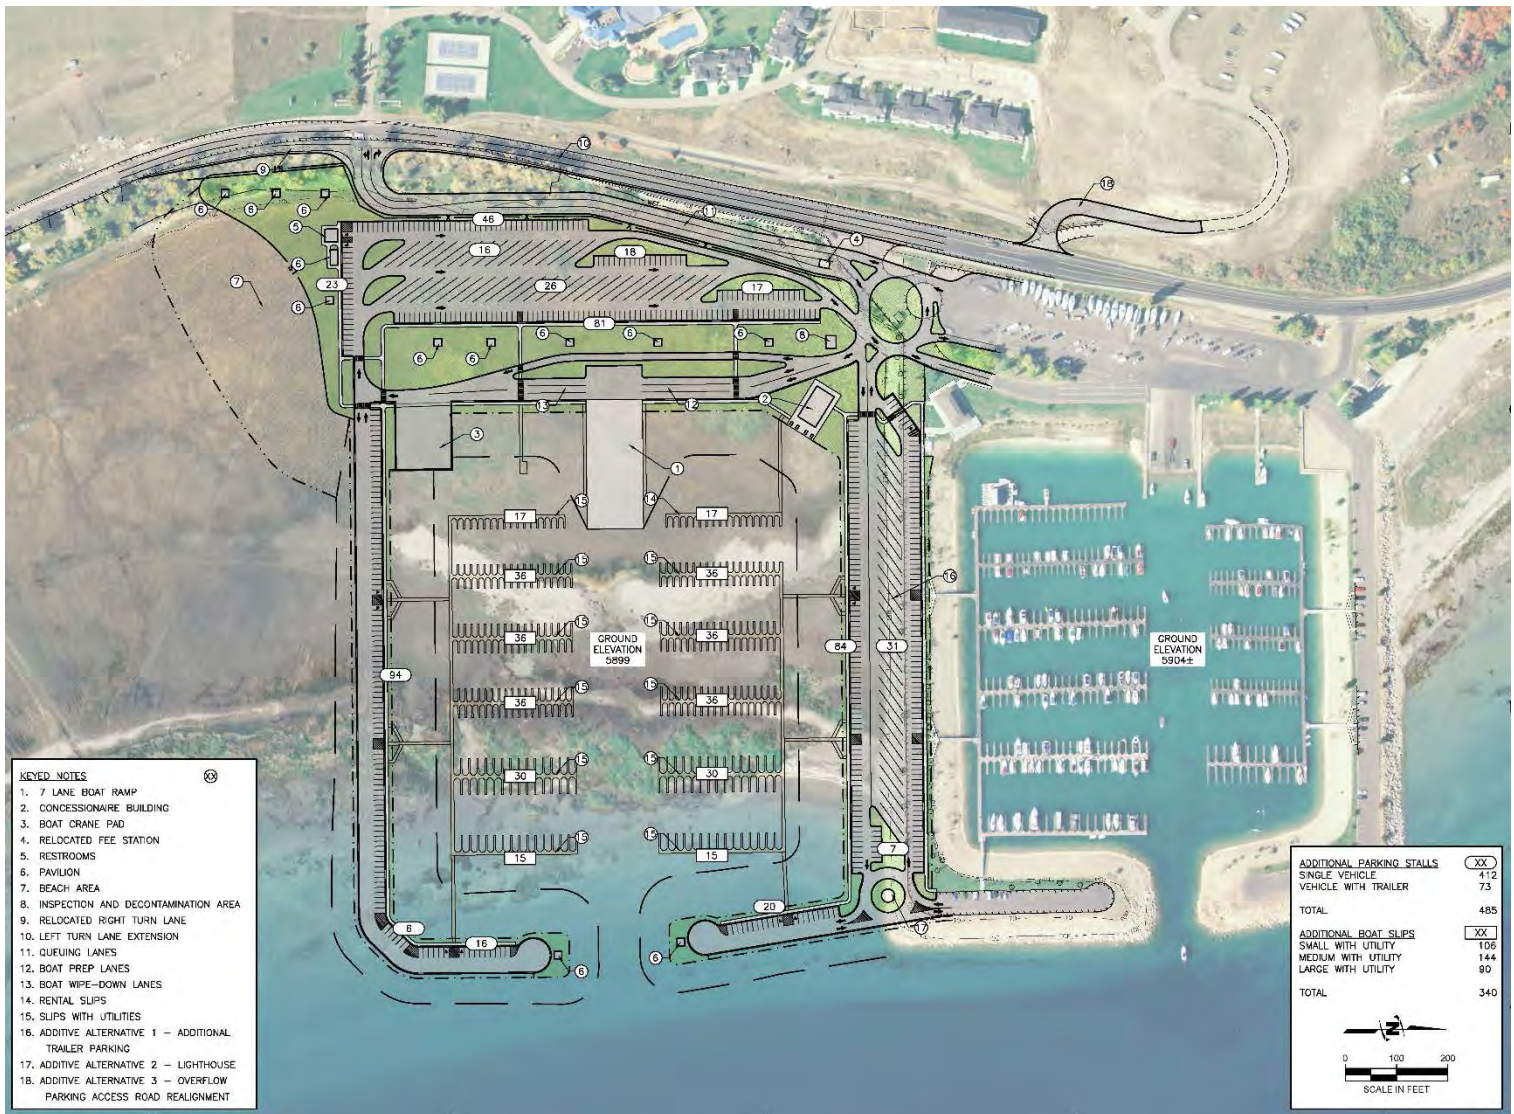
Figure 3-3: Site Plan Image

1	7-Lane Boat Ramp	84' x 252'	Ramp will need to extend into the water far enough to provide water access to the marina floor
	<b>Functions:</b> Provide easy launch for boats from land to water. <b>Occupants/ Visitors:</b> Boaters and recreationalists, State-owned boats <b>Hours:</b> Dusk until dawn; Spring to Fall. <b>Utah Space Standards:</b> Not applicable <b>Lighting:</b> None <b>Windows:</b> None <b>Views:</b> None <b>Acoustics:</b> None		<b>Security:</b> None <b>Temp, Vent and Humidity:</b> None <b>Materials:</b> Reinforced concrete with roughened surface for traction. <b>Electrical:</b> None <b>Communications:</b> None <b>Audio-visual:</b> None <b>Ceiling:</b> None <b>Furnishings:</b> None
2	Concessionaire Building	70'x40'	Concessionaire building will be finished in
	<b>Functions:</b> The Concessionaire building will operate as the location for fast food, fuel, retail sales, marine and OHV rentals. <b>Occupants/Visitors:</b> Boaters and recreationalists, beach goers, state agencies <b>Hours:</b> Dusk until dawn; May to September. <b>Utah Space Standards:</b> Not applicable <b>Lighting:</b> To be determined <b>Windows:</b> To be determined <b>Views:</b> None <b>Acoustics:</b> None		<b>Security:</b> (cameras, locks on doors and windows, metal gates) <b>Temp, Vent and Humidity:</b> Standard furnace/AC, ventilation above cook area, etc. <b>Materials:</b> Reinforced concrete with roughened surface for traction. <b>Electrical:</b> per design <b>Communications:</b> Internet, phone line <b>Audio-visual:</b> None required <b>Ceiling:</b> (height) <b>Furnishings:</b> None

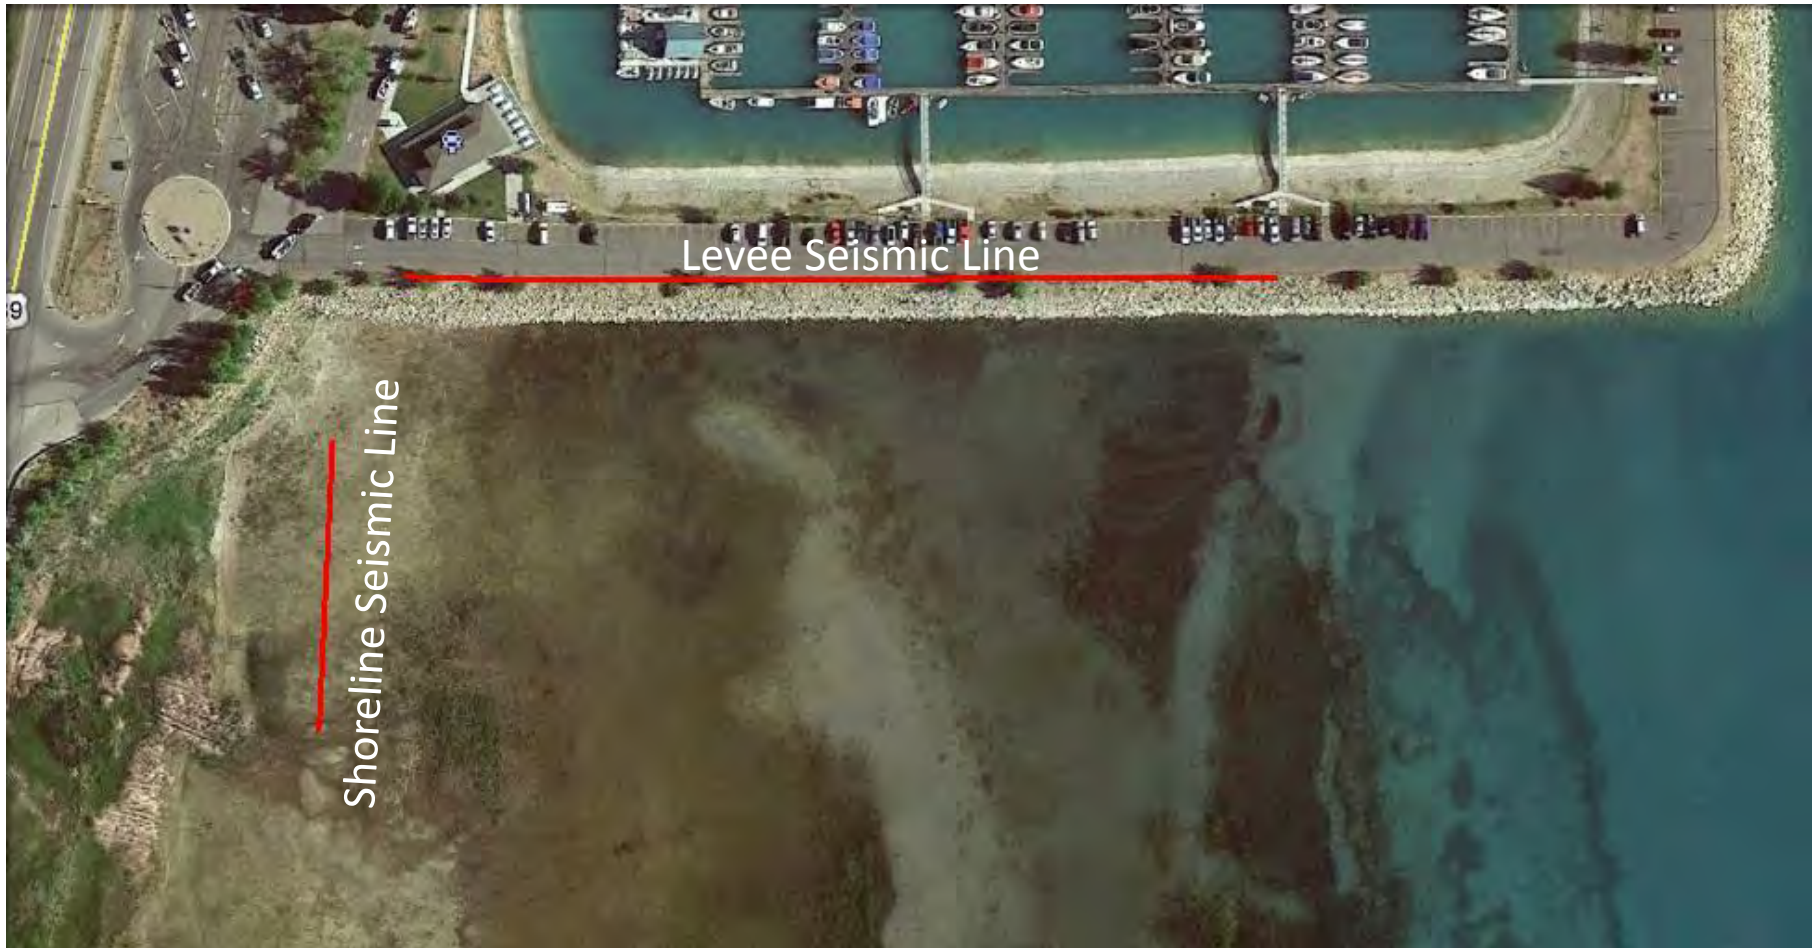
Exhibit: A-12

— SEISMIC SURVEY LINE LOCATION

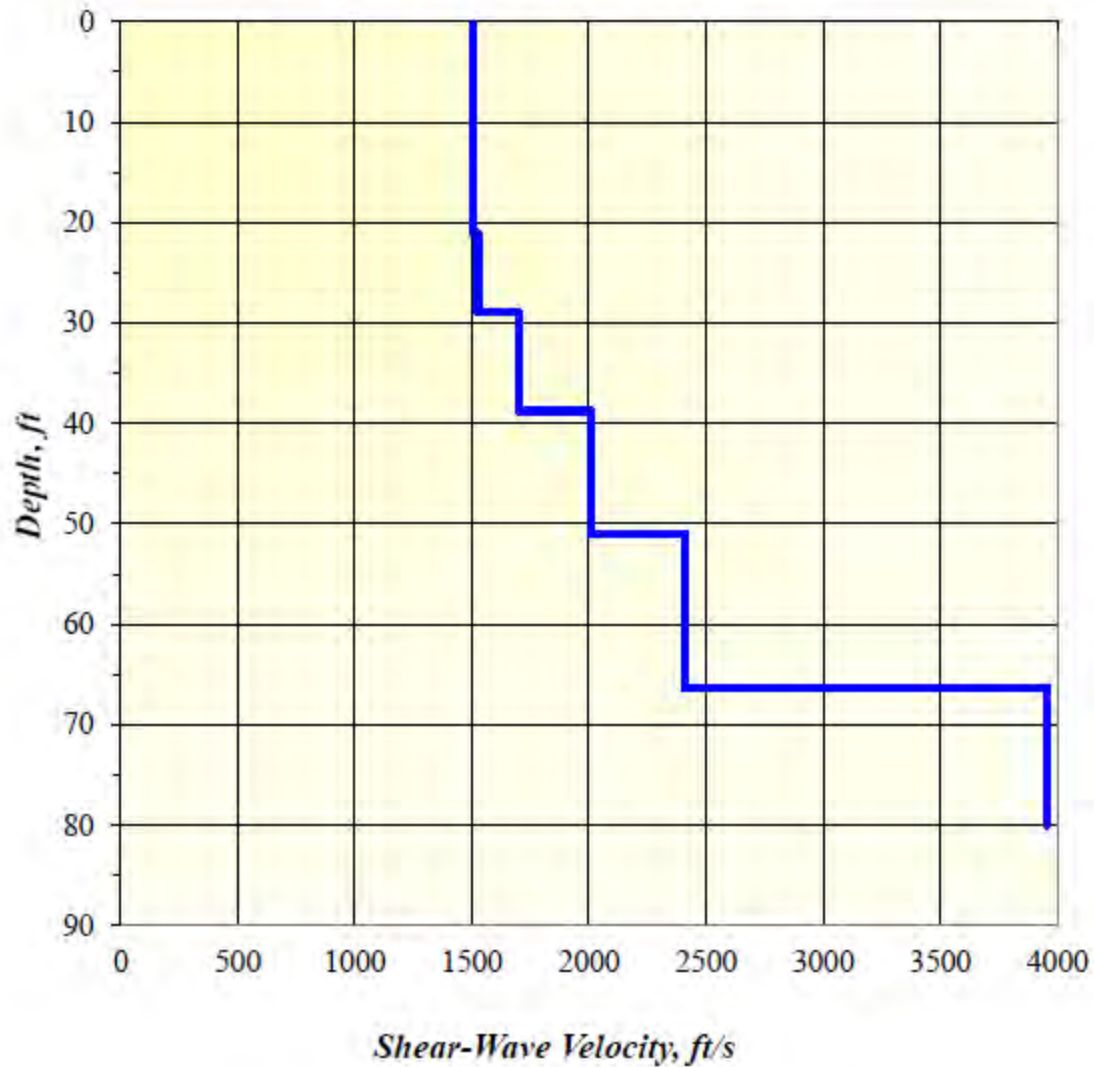
**Shoreline -  $V_s$  Profile**  
**Bear Lake Marina Expansion**

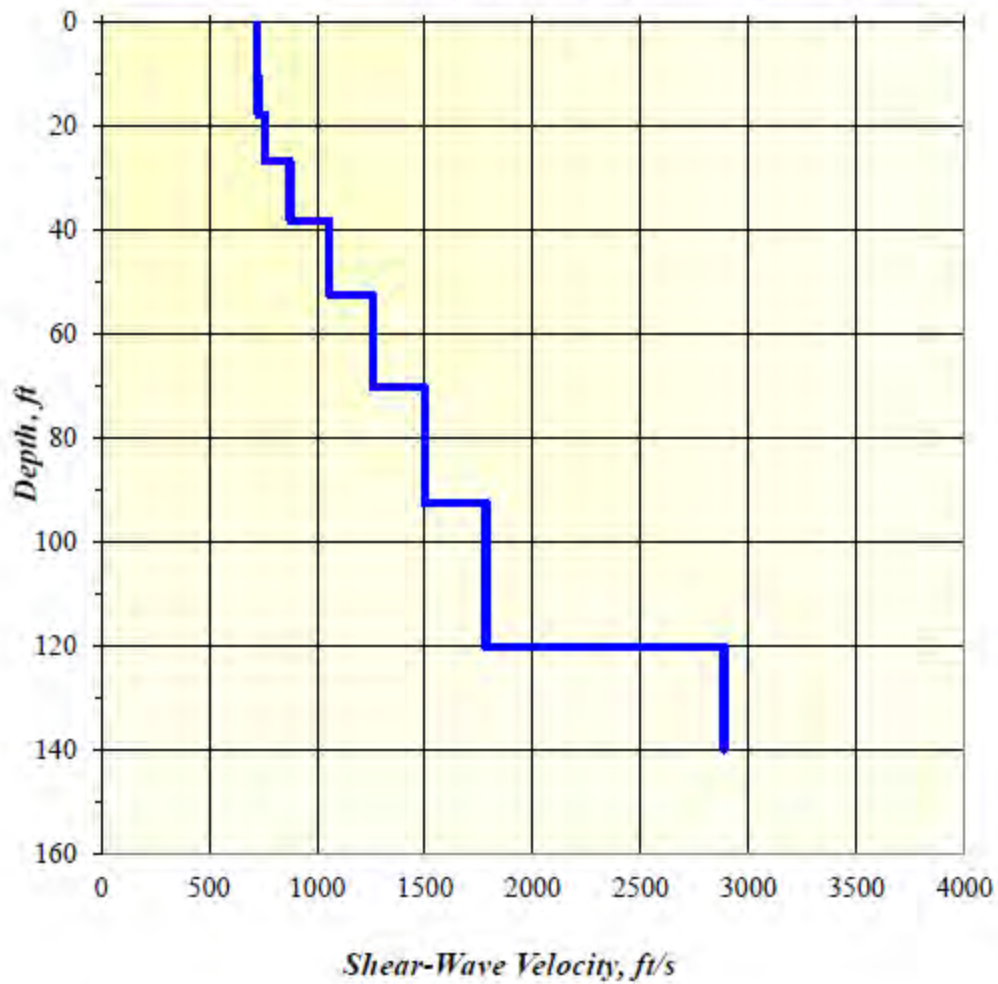
**Dyke -  $V_s$  Profile**  
**Bear Lake Marina Expansion**

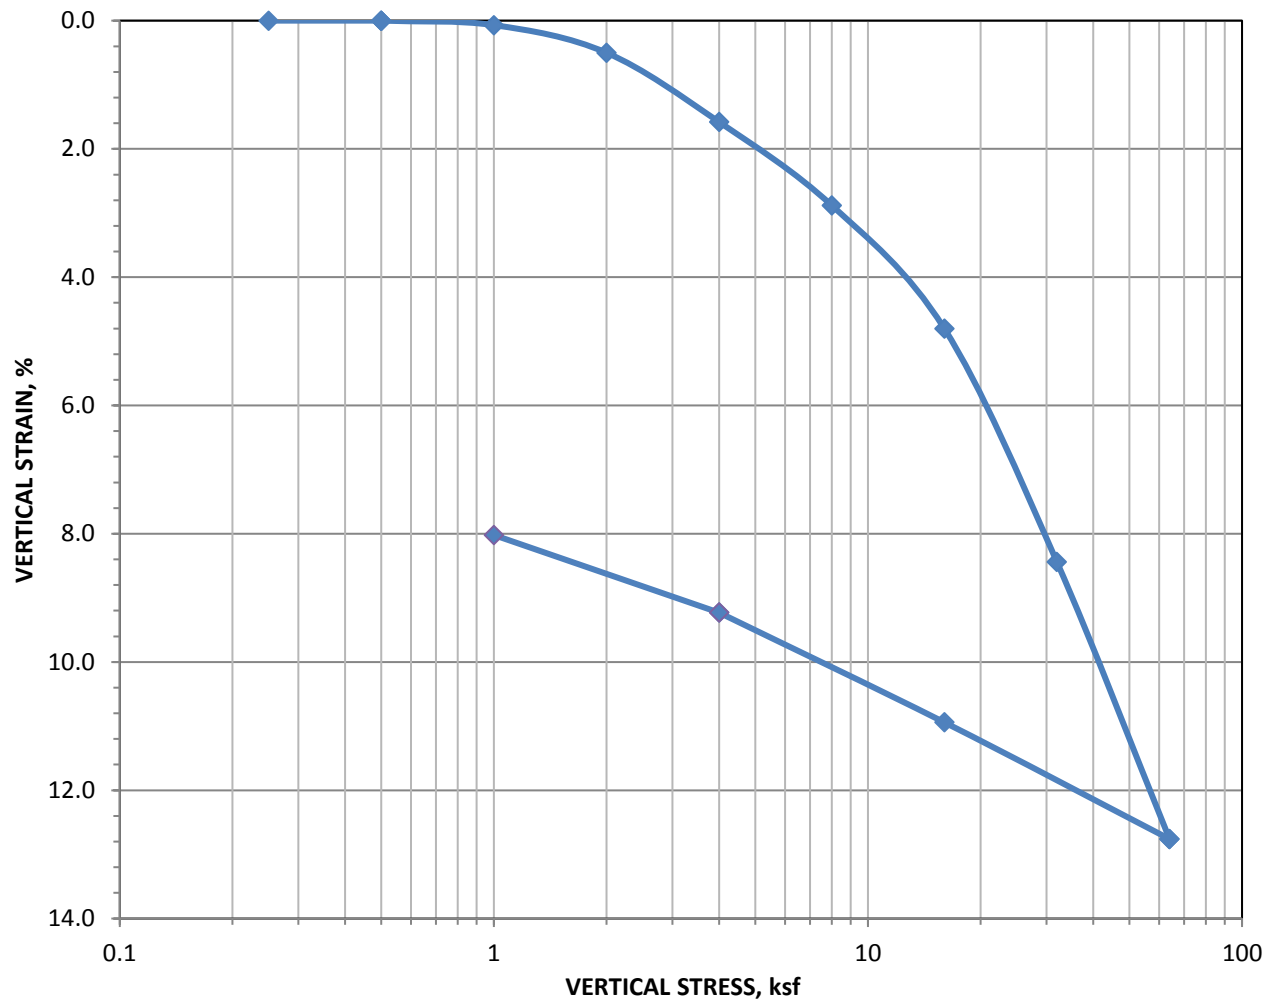
## Consolidation Test Data (ASTM D 2435-04 )

Sample Diameter (in):	2.50	Moist Unit Weight (pcf):	<b>117</b>
Sample Height (in):	1	Moisture Content (%):	<b>34</b>
Sample Volume (cf):	0.0028	Dry Unit Weight (pcf):	<b>87</b>

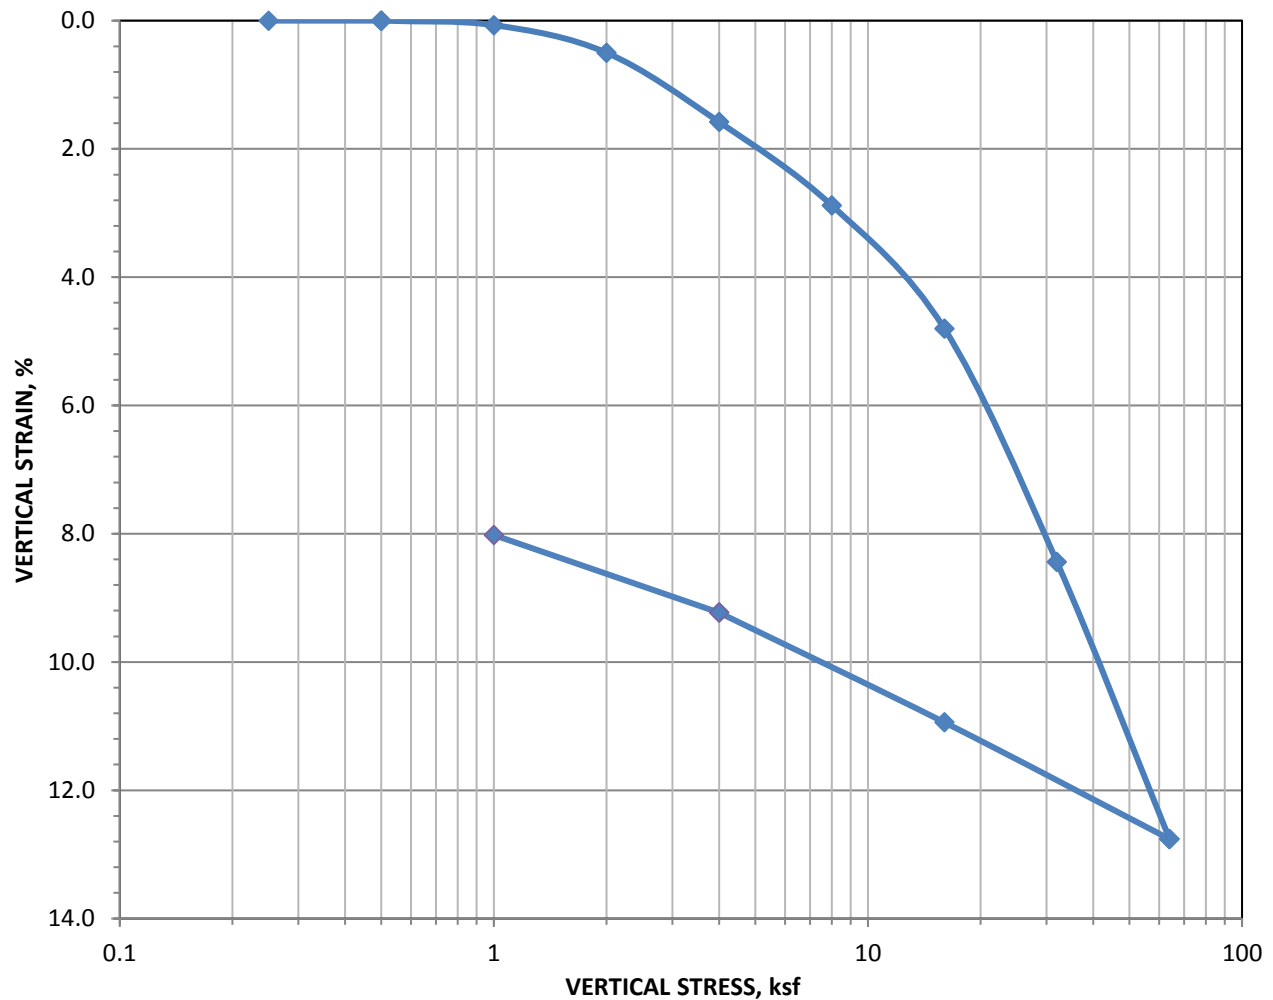
## Consolidation Test Data (ASTM D 2435-04 )

Sample Diameter (in):	2.50	Moist Unit Weight (pcf):	<b>124</b>
Sample Height (in):	1	Moisture Content (%):	<b>29</b>
Sample Volume (cf):	0.0028	Dry Unit Weight (pcf):	<b>96</b>

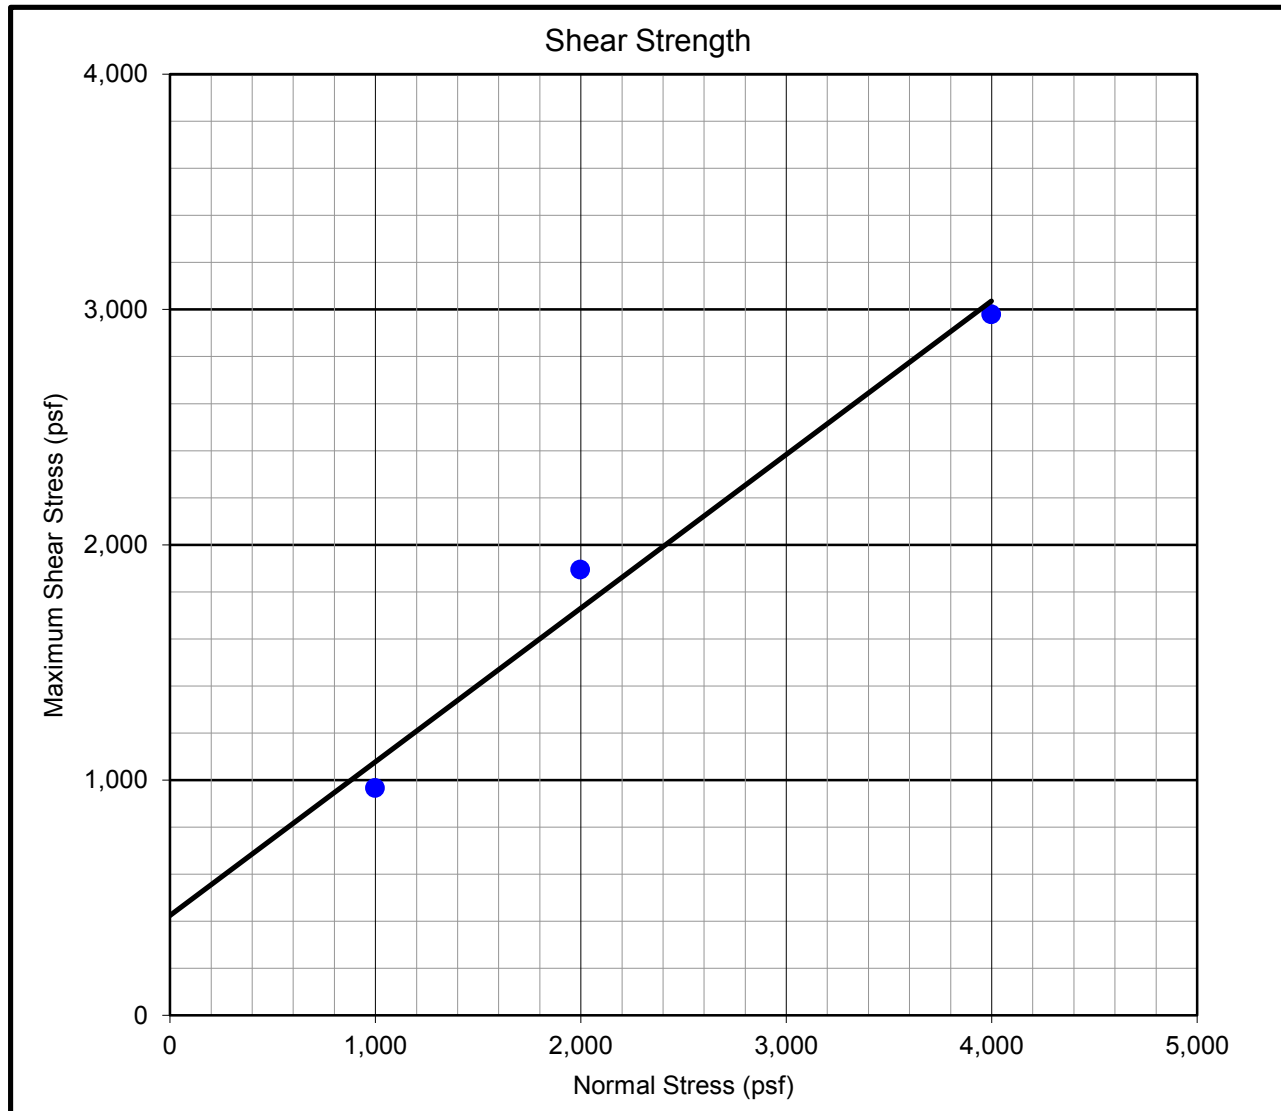
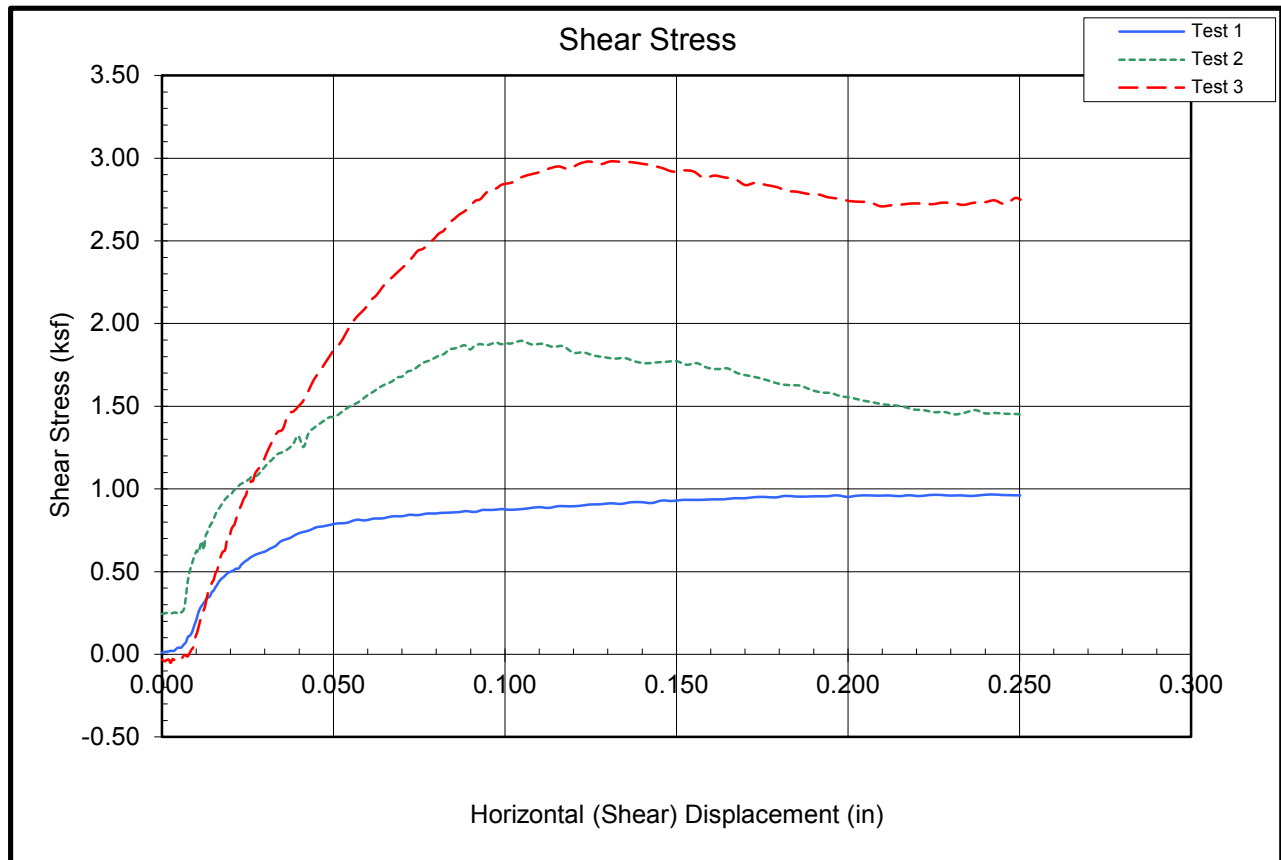
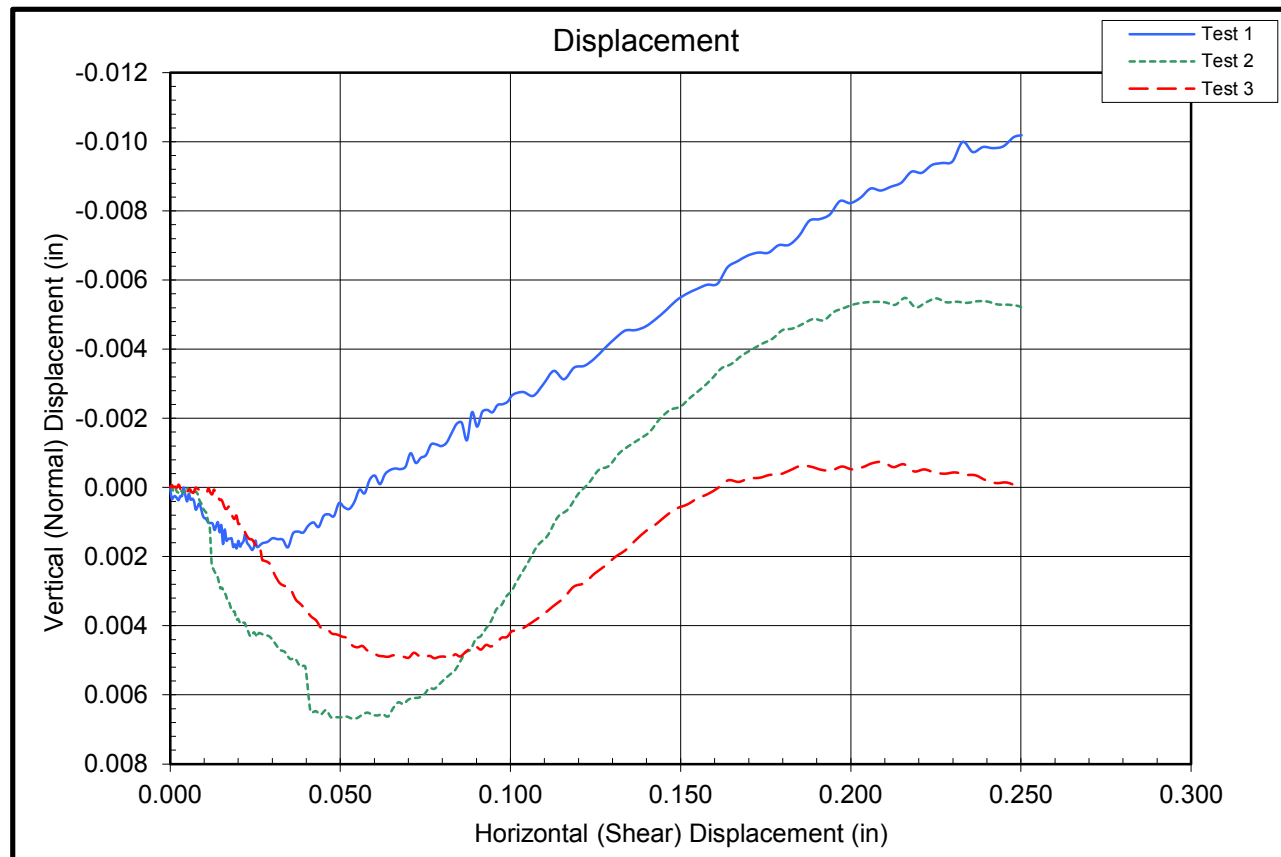
Sample Location: B-1 @ 22

Sample Information				Test Stresses		Initial Conditions			Final Conditions	
Test #	Sample Lab ID	Depth (ft)	Diameter (in)	Normal (psf)	Max Shear (psf)	Height (in)	Moisture (%)	Density (pcf)	Height (in)	Moisture (%)
1	A	22	2.41	998.8	966.8	1.00	17.6	120.6	1.00	21.2
2	B	22	2.41	1,997.8	1,895.4	1.00	17.6	120.7	1.00	21.2
3	C	22	2.41	3,998.8	2,980.4	1.00	17.6	120.3	1.00	21.4

Friction Angle (°)	33
Cohesion (psf)	425
Shear Rate (in/min)	0.01

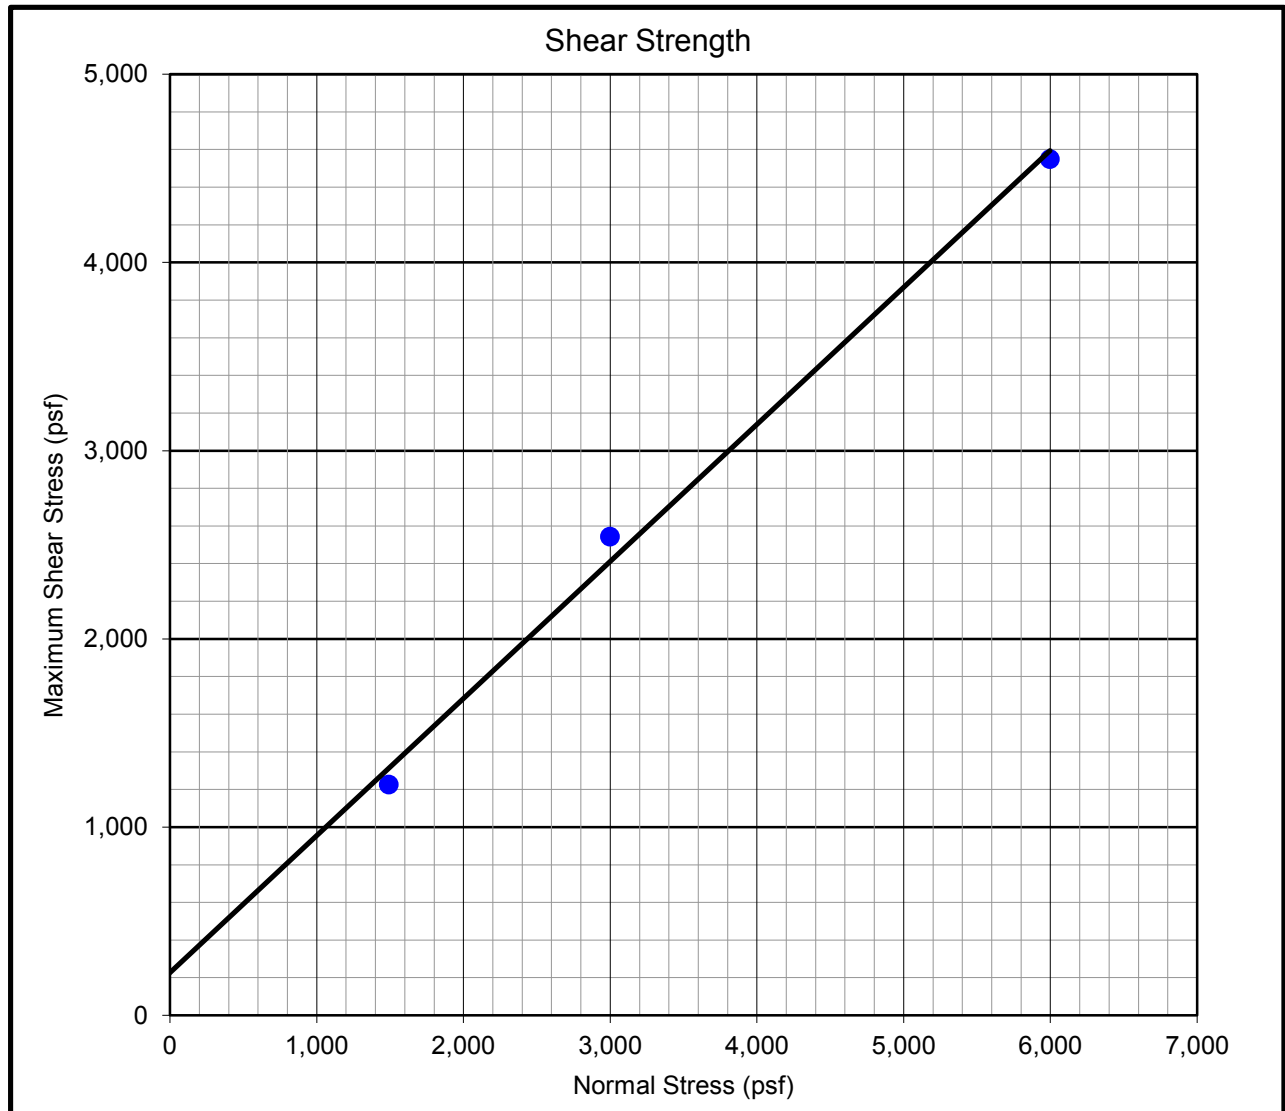
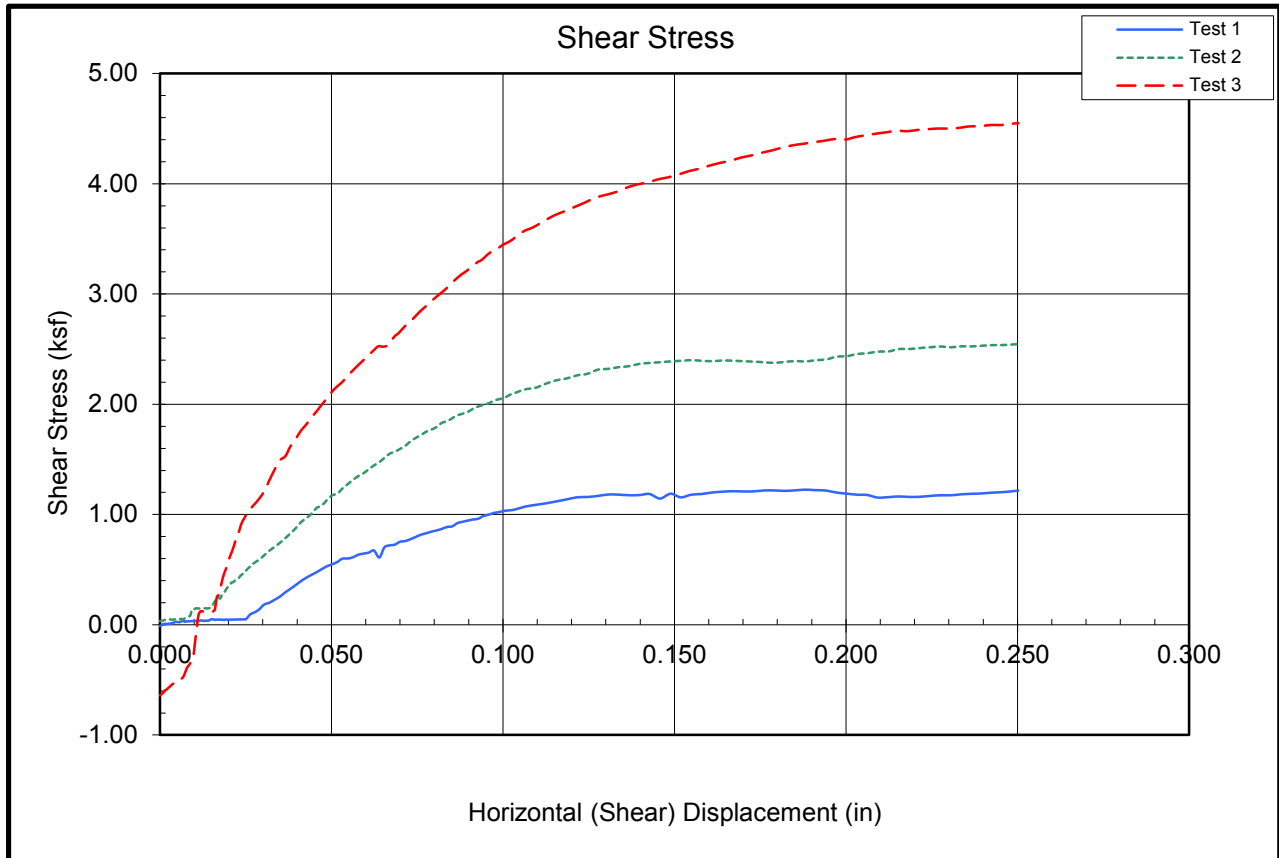
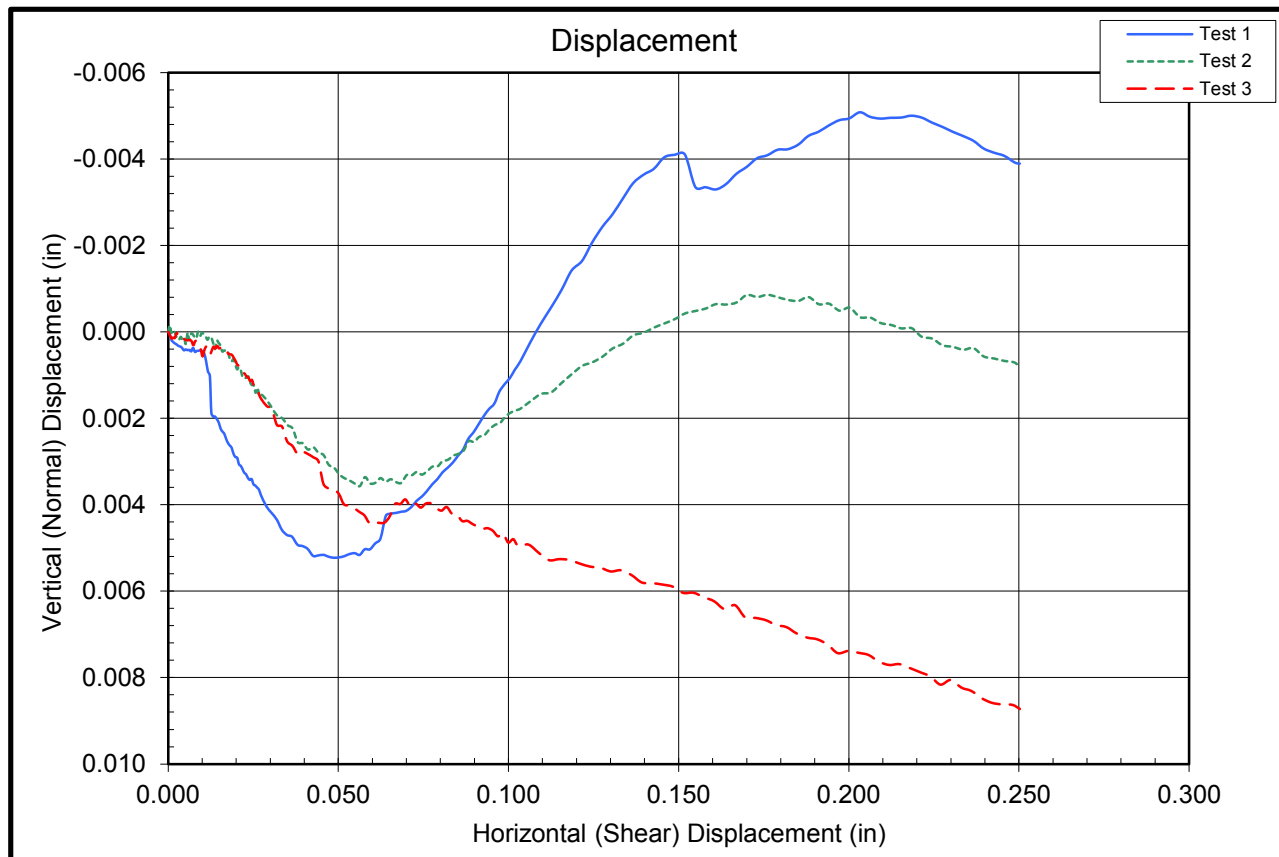
Sample Location: B-1 @ 47B

Sample Information				Test Stresses		Initial Conditions			Final Conditions	
Test #	Sample Lab ID	Depth (ft)	Diameter (in)	Normal (psf)	Max Shear (psf)	Height (in)	Moisture (%)	Density (pcf)	Height (in)	Moisture (%)
1	A	47	2.41	1,491.2	1,225.4	1.00	18	118.1	1.00	21.7
2	B	47	2.41	2,998.3	2,543.7	1.00	18	118.9	1.00	21.3
3	C	47	2.41	5,997.1	4,549.2	1.00	18	118.6	1.00	21.6

Friction Angle (°)	36
Cohesion (psf)	228
Shear Rate (in/min)	0.01

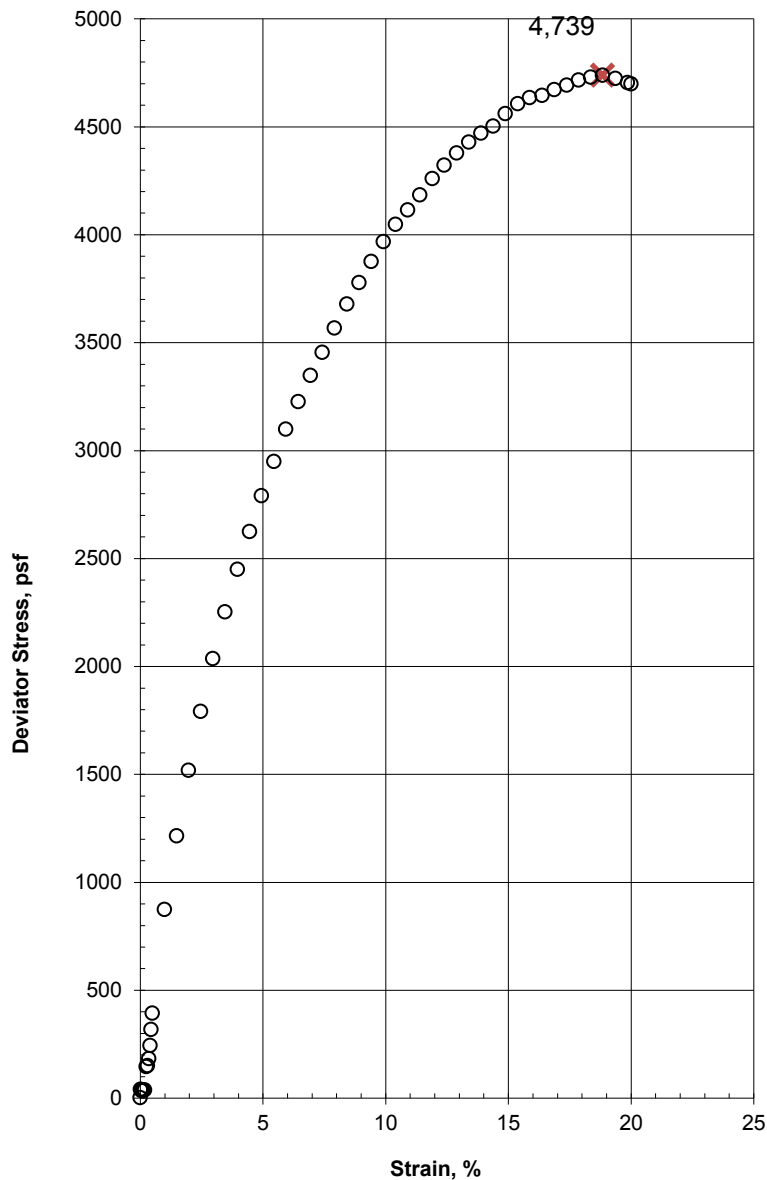
## Unconsolidated-Undrained Triaxial Compression Test (ASTM D2850)

Axial Strain (%)	Deviator Stress (psf)	Shear Stress (psf)
0.00	2.2	1.1
0.04	35.5	17.8
0.12	36.7	18.3
0.25	146.2	73.1
0.34	183.8	91.9
0.44	317.8	158.9
0.99	874.6	437.3
1.96	1519.1	759.5
2.95	2035.7	1017.9
3.95	2449.7	1224.9
4.94	2791.4	1395.7
5.93	3099.0	1549.5
6.93	3348.3	1674.1
7.91	3568.0	1784.0
8.91	3777.8	1888.9
9.90	3967.5	1983.7
10.89	4115.4	2057.7
11.90	4259.8	2129.9
12.89	4379.3	2189.7
13.89	4470.9	2235.5
14.87	4560.6	2280.3
15.87	4634.9	2317.5
16.87	4672.4	2336.2
17.86	4716.7	2358.4
18.85	4739.2	2369.6
19.86	4704.3	2352.2

Sample Diameter (in): 2.87  
 Sample Height (in): 6.119333  
 Sample Volume (cf): 0.0228
